COMPLEX INSPECTION REPORT

Raw Coal > Transfer Chutes

TC01 Deflector

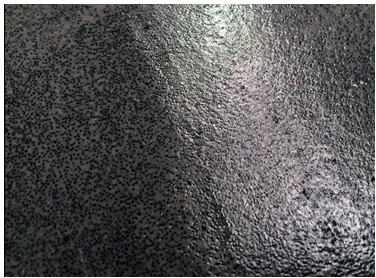
Status	Type	Condition	Detail	Action	Inspection By	Age
Liners 4, 5, 6, 7, 9, 10, 11, 12, 13						
Open	Visual	Unknown	[Faults: Other] Unable to sight due to build up on liners		11/10/2022 7:02:00 AM example_admin@pdsglobal.com	0
Liners 1, 20, 21, 22, 24, 25, 27						
Open	Visual	Fault Minor	[Faults: Worn] Appear to be wearing.	Recommend Thickness Testing on next shutdown	11/10/2022 7:49:00 AM example_admin@pdsglobal.com	0
Liners 46, 47, 48, 55, 56, 57						
Open	Visual	Out of Spec	[Faults: Other] Wear Resist used on liners until replacement ones are in stock	Continue to monitor	11/10/2022 8:11:00 AM example_admin@pdsglobal.com	0

Type: Visual, Date: 11/10/2022
Caption: Wear Resist.png

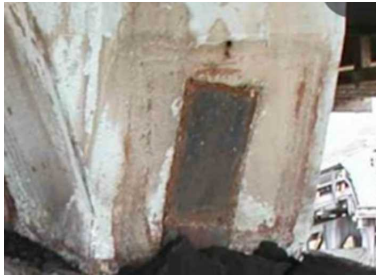
Jail Bar {}						
Open	Visual	Fault Minor	[Faults: Other] not shutting properly	10/10/2022 11:36:00 AM example@pdsglobal.com	0	
Dust Curtain {}						
Closed	Visual	Good		11/10/2022 8:01:01 AM example_admin@pdsglobal.com	0	
Parent Metal {}						
Open	Visual	Fault Minor	[Faults: Corroded] Existing patches corroded.	Continue to monitor	11/10/2022 8:02:00 AM example_admin@pdsglobal.com	0

Type: Visual, Date: 11/10/2022
Caption:
Chute.png
