FAILURE KPI REPORT FOR IDLER CONFIGURATIONS

Displays an analysis of failures for each idler configuration for the selected business / group / department / area

Filter by Period : (changed between 16/07/2017 and 16/08/2017)

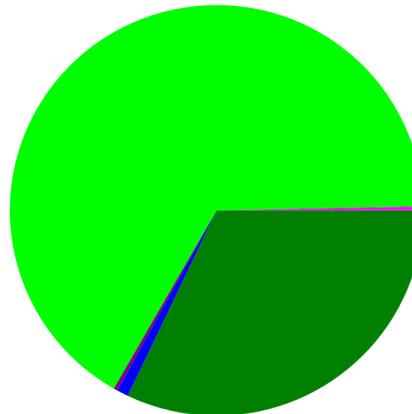
Summary of Idler Failures by Idler Configuration
