CONVEYOR INSPECTION REPORT

Raw Coal > Conveyors

Drift Conveyor

Total belt length: 2906m

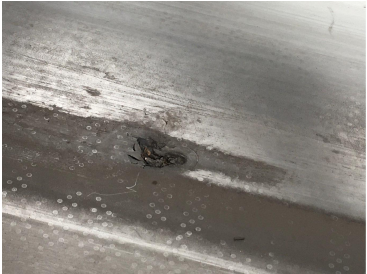
EQUIPMENT: (4) ST1000 1600 6.0+3.0 S GRADE(LENGTH (M): 412)

OPEN	Visual	OUT OF SPEC	[Faults: Puncture] [Top:] Small puncture in belt 15m behind Splice, 500mm for LHS edge.	Requires hot repair to prevent further damage.	13/02/2018 2:53:33 PM demo@pdsonline.com.au
		GOOD	[Bottom:] -

Type: Visual, Date: 13/02/2018
Caption: 1504057007359.jpg

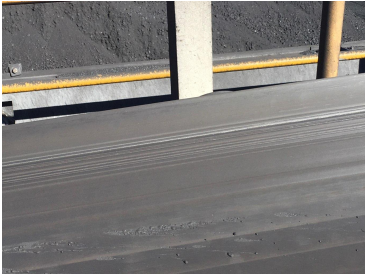
EQUIPMENT: (9) ST1000 1600 6.0+3.0 S GRADE(LENGTH (M): 396)

OPEN	Visual	OUT OF SPEC	[Faults: Grooved cover] [Top:] Grooved in skirt lines on both sides.	Continue to monitor wear in skirt lines.	13/02/2018 2:57:28 PM demo@pdsonline.com.au
		GOOD	[Bottom:] -

Type: Visual, Date: 13/02/2018
Caption: 1503630031293.jpg

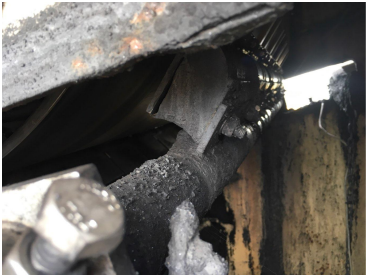
Status	Type	Condition	Detail	Action	Inspection By
EQUIPMENT: (2) SECONDARY CLEANER (LOCATION: HEAD , MANUFACTURER: FLEXCO)					
OPEN	Visual	MAJOR FAULT	[Faults: Cushion Damaged] Damaged cushion 1st tip in from LHS, has left S/S arm rubbing on belt	Requires replacement at first available opportunity to prevent belt damage.	13/02/2018 3:14:49 PM demo@pdsonline.com.au

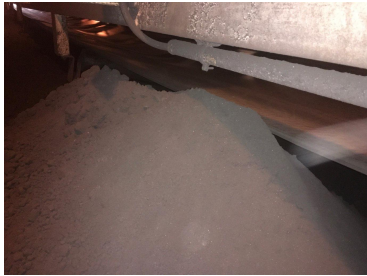
Status	Type	Condition	Detail	Action	Inspection By
EQUIPMENT: (5) V-PLOUGH (LOCATION: TAIL, MANUFACTURER: ESS)					
OPEN	Visual	FAULT MINOR	[Faults: Spillage Build Up] V-plough working as intended, but cleaned product has built up to the belt height at the tail.	Requires regular hosing.	13/02/2018 3:19:12 PM demo@pdsonline.com.au

Type: Visual, Date: 13/02/2018
Caption: 1503629807879.jpg

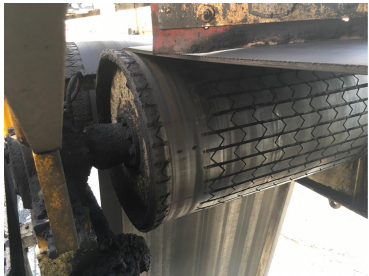
EQUIPMENT: (4) BEND EXIT (LAGGING TYPE: POLY STRIP)

OPEN	Visual	OUT OF SPEC	[Faults: Lagging wear on belt line] Wearing on belt line both sides. Down to backing rubber now.	Monitor for replacement	13/02/2018 3:12:58 PM demo@pdsonline.com.au
------	--------	-------------	---	-------------------------	--

Type: Visual, Date: 13/02/2018
Caption: 1503630728785.jpg

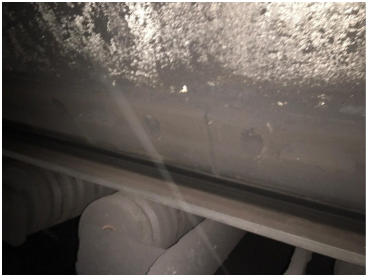
Status	Type	Condition	Detail	Action	Inspection By
EQUIPMENT: (1) TAIL (MATERIAL TYPE: RUBBER, THICKNESS/LENGTH: 12 / 12)					
OPEN	Visual	OUT OF SPEC	[Faults: requires replacement] Sections on both sides have worn, with spillage apparent.	Skirt rubber requires replacement.	13/02/2018 3:20:11 PM demo@pdsonline.com.au

Type: Visual, Date: 13/02/2018
Caption: 1503629852220.jpg
