COMPLEX INSPECTION REPORT

Raw Coal > Transfer Chutes

TC01 Deflector

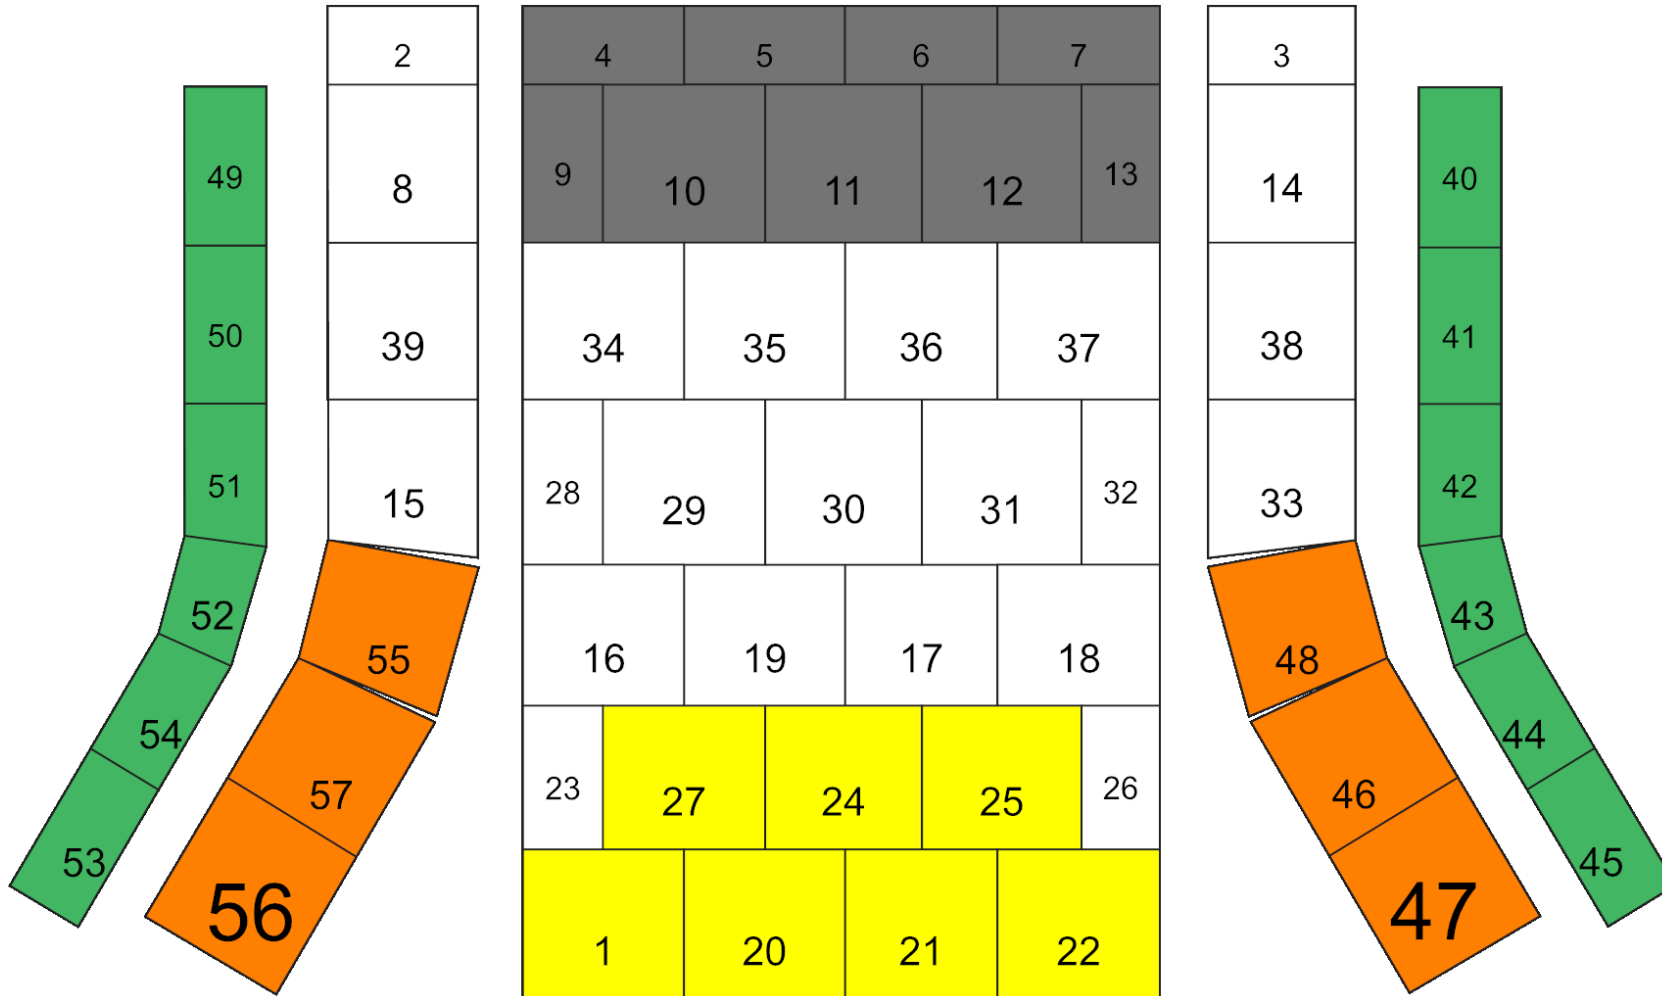
Status	Type	Condition	Detail	Action	Inspection By	Age
Liners 4, 5, 6, 7, 9, 10, 11, 12, 13						
Open	Visual	Unknown	[Faults: Other] Unable to sight due to build up on liners		11/10/2022 7:02:00 AM example_admin@pdsglobal.com	0
Liners 1, 20, 21, 22, 24, 25, 27						
Open	Visual	Fault Minor	[Faults: Worn] Appear to be wearing.	Recommend Thickness Testing on next shutdown	11/10/2022 7:49:00 AM example_admin@pdsglobal.com	0
Liners 46, 47, 48, 55, 56, 57						
Open	Visual	Out of Spec	[Faults: Other] Wear Resist used on liners until replacement ones are in stock	Continue to monitor	11/10/2022 8:11:00 AM example_admin@pdsglobal.com	0
